Solar Thermosyphon Failure Analysis

**Report B.2. A survey of thermosyphon
failure modes, and effects, and suggestions**

*This is a report from SHC Task 69: Solar Hot Water for 2030
and work performed in Subtask: Thermosyphon hot water
systems*

Report number: B.2 DOI: 10.18777/ieashc-task69-2026-0002

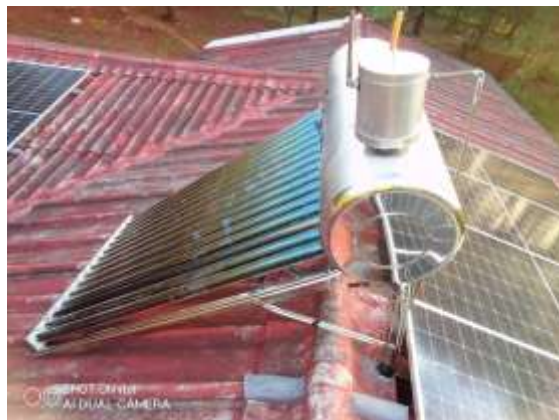
Cause: Wrong way of installation of solar geyser would lead to roof breaking.

Effect: The roof would break and damage or lead to water leaks in the roof.

Example: Figure shows below the examples of wrongly installed solar collector that has the roof not inspected.

Figure 1: Wrong way of installation of solar geyser would lead to roof breaking.

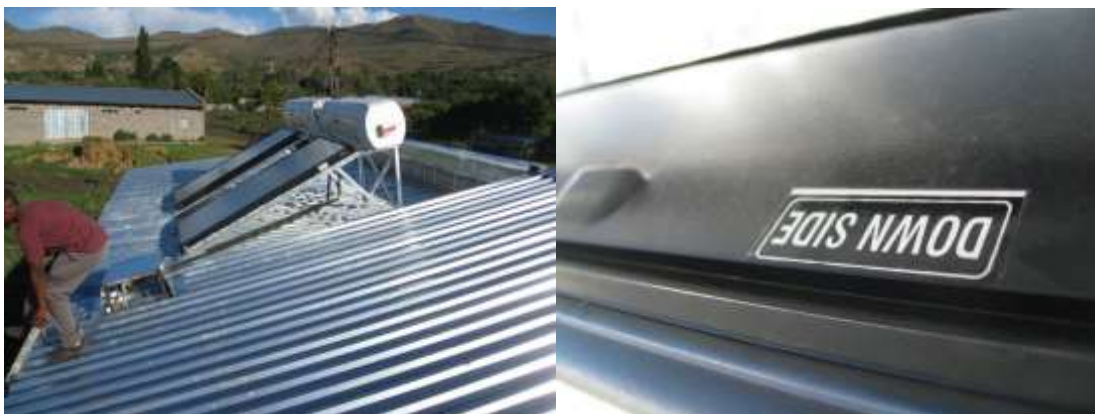
Cause: The storage tank is installed below or level with the top of the collector. The circulation pipe connecting the collector and the water tank has an “inverted slope” or “air pocket.” Exhaust valve position incorrect or missing. The installation position of the supply water tank is too low.

Effect: Improper installation of pipes or components can result in slow system circulation, reduced efficiency, or even complete system failure. It also poses potential safety hazards.

Example: Figure 2 shows an example of a collector being installed backwards.

Figure 2: Poor positioning of the collector (Source: Rudi Moschik, AEE-Institute for Sustainable Technologies).

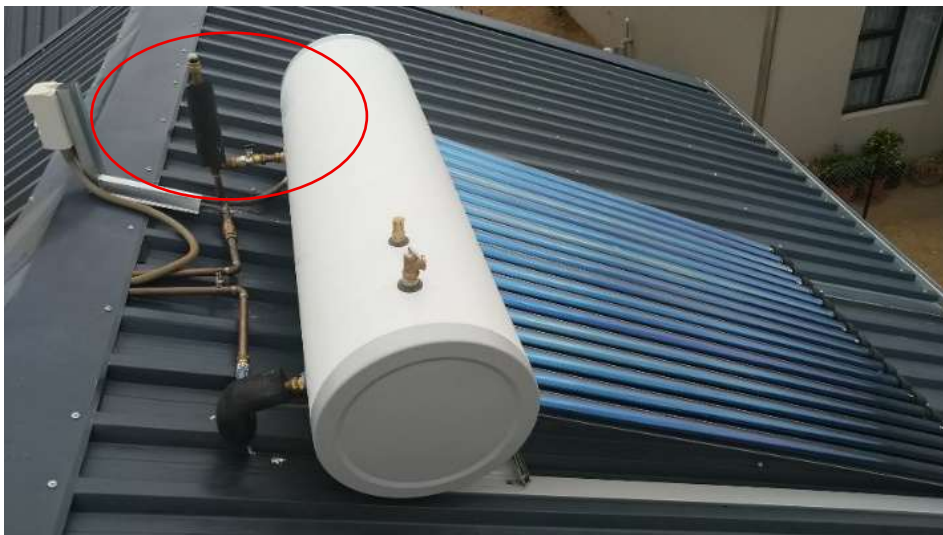
Cause: Incorrect installation of vacuum breaker. There is no thermosyphon loop in place to prevent back flow out of the tank in case there is not sufficient cold-water supply.

Effect: In case of not having enough water supply, the tank will be drained by leaving the taps open, which were positioned lower as the tank. Having an empty tank, this phenomenon can easily destroy the electrical heating element in the tank.

Example: Figure shows below the examples of wrong positioning or installation of vacuum breaker.

Figure 3: Wrong positioning / installation of vacuum breaker.

Strictly require installation only at the designated, verified highest point in the thermosyphon loop (typically the condenser outlet or reservoir vent line). Utilize system P&IDs and 3D models for unambiguous location identification during design and construction. Specify and validate the required flow direction/port orientation (e.g., arrow on valve body). Use installation drawings with detailed isometric views showing the exact mounting angle. Define and enforce specific torque values for valve installation (nuts, unions) using calibrated tools to prevent under/over-tightening causing leaks or thread damage. Conduct a thorough system-wide pressure decay test and vacuum hold test after vacuum breaker installation. Position the vacuum breaker where it is readily accessible for inspection and functional testing but protected from accidental impact.

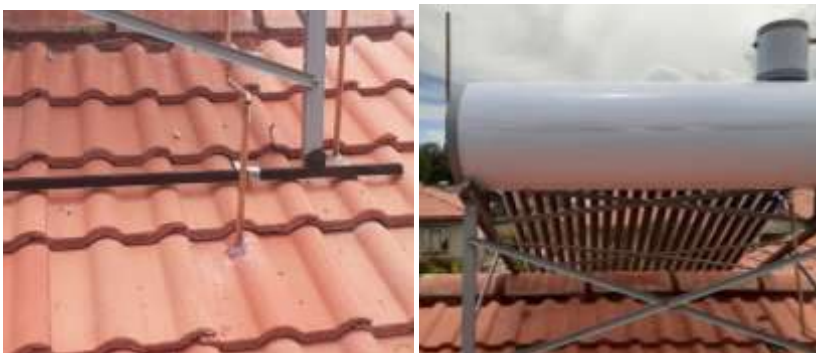
Cause: Insufficient hot water in the morning provision by the system and oversizing systems to compensate for heat loss.

Effect: Oversizing systems and poor performance of the systems.

Example: Examples of uninsulated solar collector outlet pipes.

Figure 4: Missing insulation on the copper hot water pipe.

Require insulation on all critical components – evaporator, condenser, piping (vapor and liquid lines), reservoirs, and valves – with zero gaps. Explicitly prohibit uninsulated "convenience gaps" at supports or instruments. Calculate and specify insulation thickness using industry standards based on maximum allowable heat flux, operating temperatures, ambient conditions, and economic thickness analysis. Ensure thickness compensates for thermal bridging. Use rigid insulation or install protective sleeves/cladding over softer materials at pipe supports, hangers, and anchor points to maintain thickness and avoid thermal bridging. Establish scheduled visual inspections for cladding integrity, sealant condition, and physical damage. Prioritize areas prone to impact or weather exposure. Implementation of these solutions minimizes parasitic heat loss, maintains the critical temperature gradient for efficient thermosiphon operation, prevents subcooling/stagnation or premature boiling, reduces energy costs, and ensures long-term system reliability and safety.

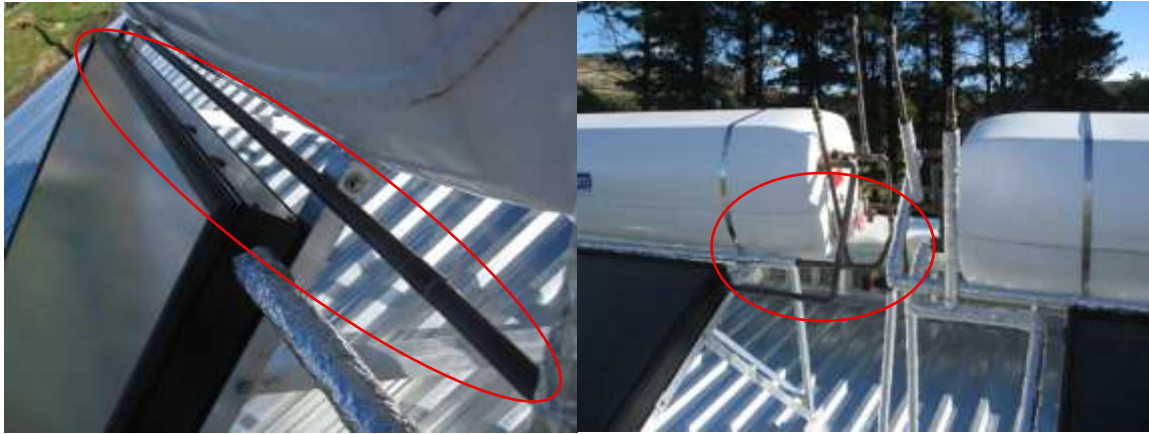
Cause: Heat losses by the system due to lacking insulation

Effect: Frustration of the client, and water coming out cold of the solar heating system; Outdoor pipes frozen in winter stopping hot water from working and causing leaks; When temperatures drop below zero uninsulated pipes can freeze putting pressure on the pipes causing water not coming out of the taps; Heating system making gurgling sounds when switched on; In winter the pipes can get frozen causing water not to flow out due to freezing pipes because of missing insulation; Long distances uninsulated pipes can lead to wastage of water because the water in the pipe remain cold.

Example: Figure 5 shows the missing insulation protection.

Figure 5: Missing insulation protection (Source: Rudi Moschik, AEE-Institute for Sustainable Technologies).

- Avail various insulation protection materials on the market.
- Adopt standards and develop codes of practice and regulations to enforce regulations.
- Define roles and responsibilities of installers, technicians, and inspectors.

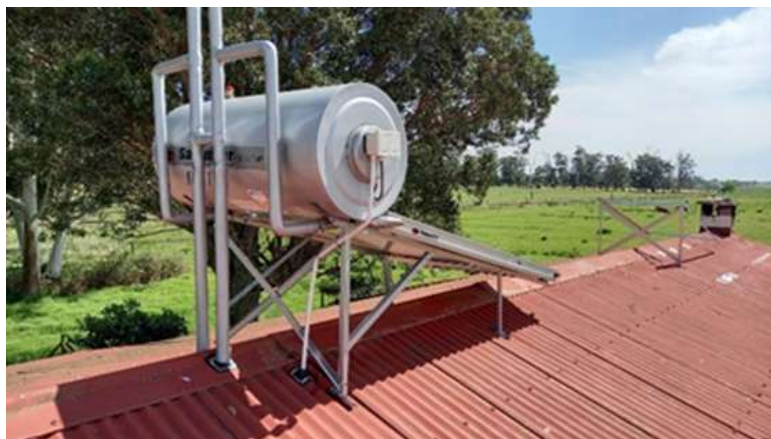
Figure 6 illustrates the correct installation of solar collectors with robust insulation protection using a reflective protective material.

Figure 6: Protection of the insulation material using a weather-proof material that is not susceptible to bird damage.

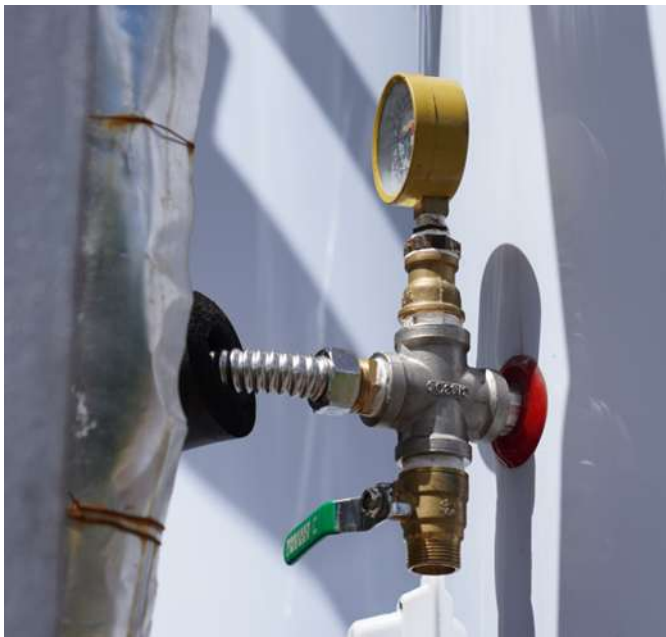
Cause: The water is not circulating; danger of explosion of the tank and no client protection; the tank could spring a leak or explode if pressure relief does open or missing when the tank is overheated and if it cannot contain normal water pressure it begins discharging and wasting water

Effect: Frustration of the client, and water not coming out of the solar heating system due to ruptured pipes.

Example: Figure 7 shows the missing safety components (air release, PRV, filling and flushing valves)

Figure 7: Missing safety devices. (Source: Rudi Moschik, AEE-Institute for Sustainable Technologies).

To overcome these faults, the following actions are suggested:

- Standardized rules and regulations and construction personnel clearly delineate relevant responsibilities.
- Streamline the integrated process of construction, acceptance, and maintenance to ensure product safety.

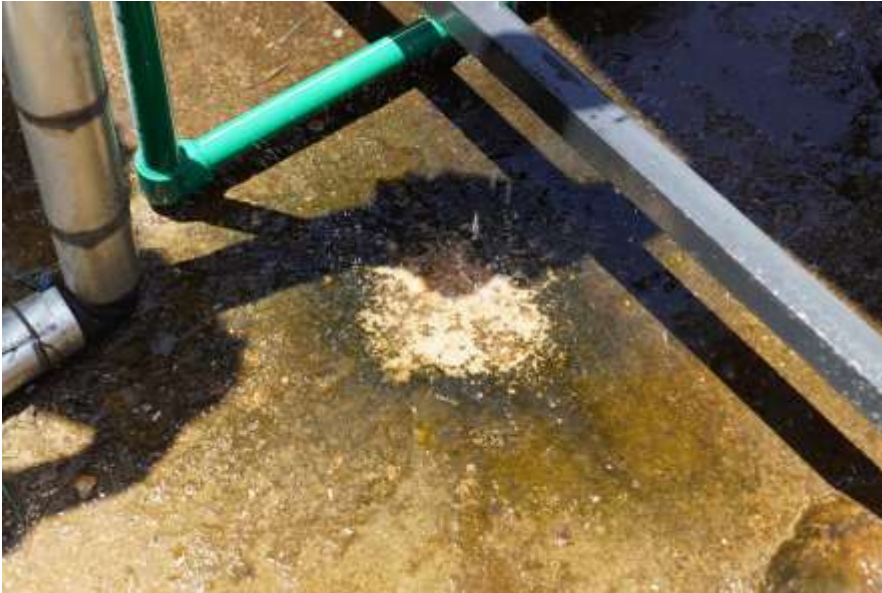
Cause: Weak points such as seals and welds are damaged; Pipes and collectors burst due to expansion from freezing; Chemical corrosion occurs inside the pipes.

Effect: Weak points such as seals and welds are damaged; Pipes and collectors burst due to expansion from freezing; Chemical corrosion occurs inside the pipes.

Example: Figure 8 shows the leakage.

Figure 9: Consequences of the leak (Source: Rudi Moschik, AEE-Institute for Sustainable Technologies).

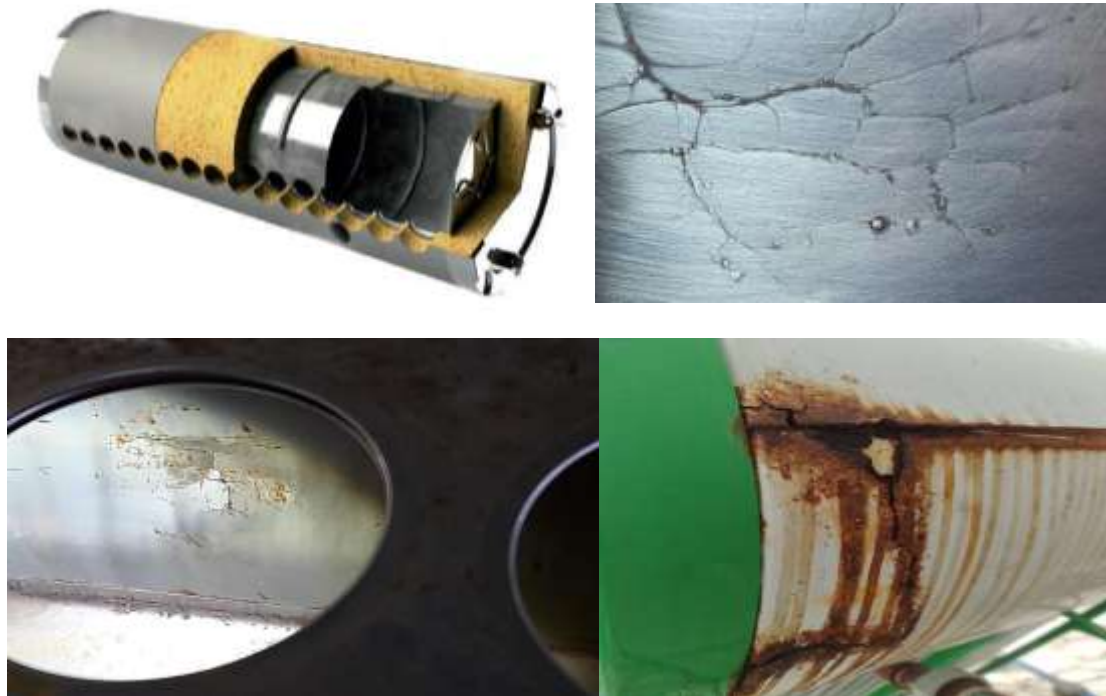
This type of stainless steel has particularly good resistance to generalized corrosion, but can present localized corrosion such as “Pitting,” “Crevice,” “MIC,” “CUI” and “SCC.” Frequent deterioration phenomenon that has been detected in equipment that fails prematurely is stress corrosion cracking (SCC), which manifests itself as intergranular and branching cracks.

Cause: By visual observation inside the accumulators, it can be known (detected) if there are micro cracks due to SCC. Typical cracks are seen on the internal surface of the tank, mainly in the deformed areas and close to the welded joints of the equipment.

Effect: Cracks cause the accumulator to lose its tightness (they become punctured), which first causes a decrease in the thermal insulation capacity and performance (due to wetting of the insulating material); and ultimately puts the equipment out of service prematurely.

Figure 10: Corrosion phenomena solar thermal equipment.

Once this pathology has developed in a tank, repair is difficult; since when trying to repair it, secondary cracks are generated and propagate. In this case, there is no alternative but to replace the tank with a new one.
